# Union of Concerned Scientists

October 12, 2012

**Subject: San Onofre Unit 2 Steam Generator Root Cause Report and  
Proposed Restart Compensatory Measures**

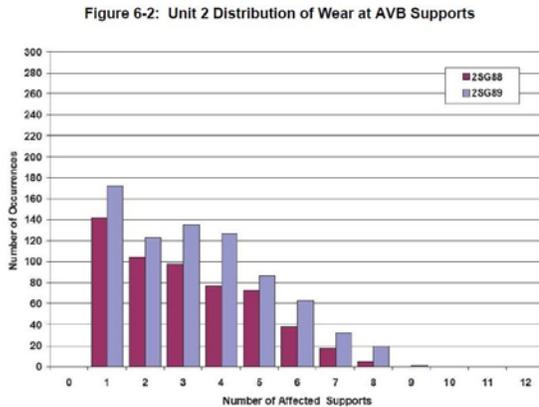
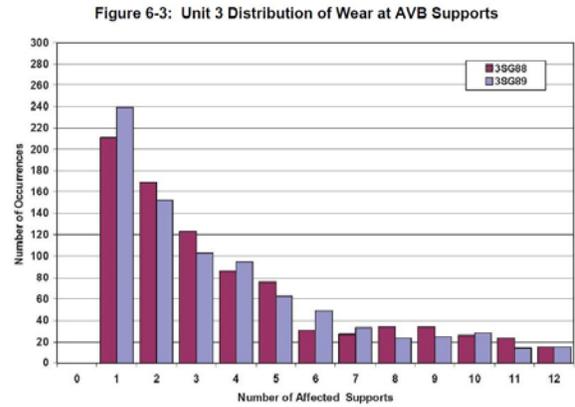
1. Figures 6-2 and 6-3 of Enclosure 2 chart the wear distribution found in the four replacement steam generators. Figure 6-2 presents the data for the two replacement steam generators on Unit 2 while Figure 6-3 presents this data for the Unit 3 replacement steam generators. Figure 6-3 shows that the two replacement steam generators on Unit 3 exhibited similar wear patterns in that the number of wear indications is roughly the same for the number of supports. But Figure 6-2 shows something different. Unit 2 replacement steam generator 2SG89 has significantly more wear indications per number of supports than does replacement

steam generator 2SG88. Until the reason for this marked difference between the wear degradation for the Unit 2 replacement steam generators is understood, the operational assessment performed for future operation is suspect.
