Environmentally Induced Transgranular Stress-Corrosion Cracking in 304L stainless steel piping and components at Koeberg

J.P. Basson ESKOM, Koeberg Nuclear Power Station
Melkbosstrand, Cape Town, South Africa

Koeberg is a seawater-cooled, 2x920 MW Pressurised Water Reactor plant, with a three-loop Framatome nuclear steam supply system. Koeberg is situated 30 km North of Cape Town, South Africa, on the Atlantic coast.

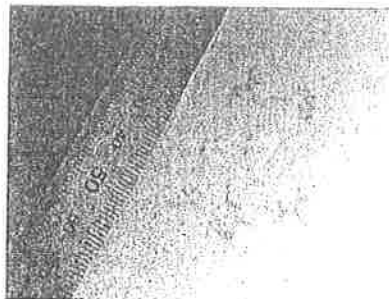
Cracks were detected on three pipe elbows during a refuelling outage in February 2001. These cracks were detected by leakage and characterised using conventional liquid penetrant testing. The cracks were mostly linear defects up to 25mm long and perpendicular to the longitudinal seam welds, but a bi-axial crack was found as well. There were no other defects detected on any other elbows during this inspection or the extended scope of inspection. The cracks were all dispositioned metallurgically by replication and confirmed to be stress corrosion cracking (SCC). During a required three monthly visual inspection subsequent to the detection of these cracks, leaks were detected on other pipes that had been 100% inspected with dye penetrant testing in February 2001. The cause of the leaks was confirmed to be SCC. The reason for the previous non-detection of these defects was the following: the cracks were through-wall at the time, internal fluid pressure in the crack had prevented dye from entering the crack and had diluted it on the surface with the effect that there was light water staining on the developer and not pink penetrant as expected.

Fig.1: Example of PT test of elbow

Since the water staining was light, the inspection personnel could not distinguish it as abnormal and did not record a defect. This event resulted in requalification of the Penetrant Testing technique for detection of defects specific to this pipe in these conditions. Penetrant dwell times were extended from the originally specified and proceduralised 30 minutes to 24 hours. Four more cases of SCC were found on all the pipes that were inspected (100% inspection). It was concluded that all defects had been found and dispositioned.

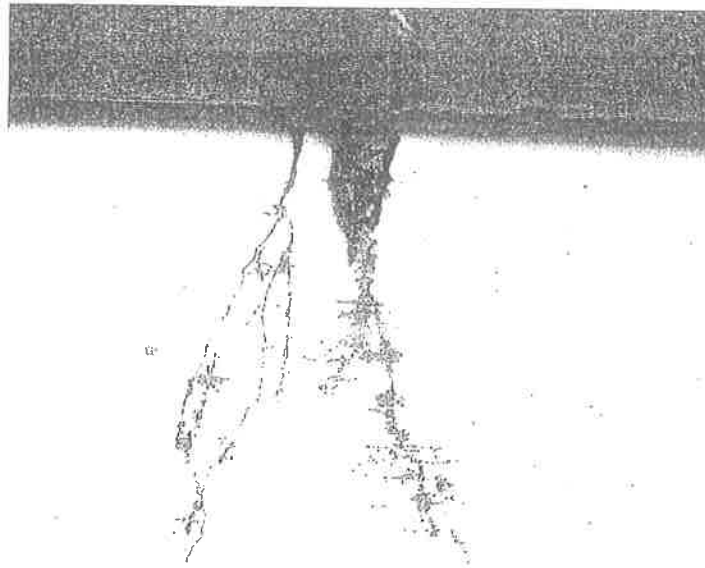
Further metallurgical investigation incorporating light surface abrasion (depth of approximately 50µm) revealed another defect that had not been detected with 24 hour Penetrant Testing. The appearance of this defect indicated that the 24 hour Penetrant Testing had no relevance for this specific defect. Metallurgical dispositioning of this specific indication revealed that there was a corrosion pit approximately at its centre.

Fig. 2: Cross-section of corrosion pit

The primary initiator of the pits is chloride deposition. Chlorides are especially harmful to the passive layer on the 300 series of austenitic stainless steels. Considering the layout of the plant, operating history, shipping, handling, construction and maintenance it is likely that during all stages, the pipe was exposed to varying levels of chloride deposition/contamination. Swipes that have been taken on top and bottom surfaces of 31 pipe sections have returned preliminary values that are exceptionally high in chlorides. Hence, regardless of initial delivery/construction conditions there are sufficient chlorides throughout the affected areas for pit formation.

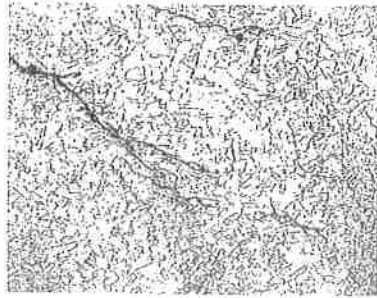
The morphology of the SCC was concluded to be as follows: the formation of a corrosion pit with subsequent subsurface SCC initiation and growth. Pits initiate on the surface and break down the passive oxide layer. The formation of a pit leads to concentration of chlorides at the bottom of the pit. Where the conditions are suitable (high residual stress), SCC can initiate and propagate from this point. The pit does not need to be very deep before SCC can develop. In this case, it was assumed that the residual stresses below the surface of the pipe were sufficiently high to initiate SCC (QADPs did not confirm solution treatment of the pipe after forming). Subsequent in-situ residual stress measurement revealed values in excess of 280 MPa. Residual stresses as low as 135 MPa have been shown to be sufficient to initiate SCC. Yield stresses were measured on previously removed pipe and found to be as high as 388MPa. This further supported the postulation that the pipe had not been solution treated after forming (high cold working and residual stresses). Optical microscopy of cracks showed it to be transgranular.

Fig.3: 100X magnification of crack

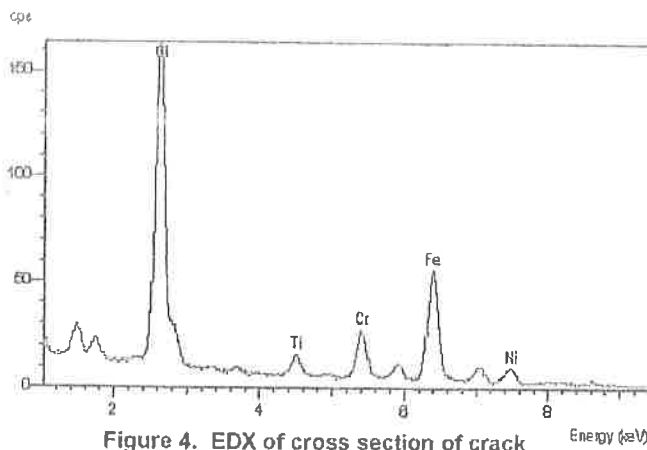
Measurement of the concentration of chemical species using Energy Dispersive X-Ray Spectroscopy (EDX) clearly shows that there is a very high concentration of chlorides in the cracks (Figure 4). The format of

Figure 4. EDX of cross section of crack

The environment is clearly localised and may vary along the length and width of the crack. The necessary electrolyte to cause pitting will have been present when the tank rooms were open to the environment (and collected within the insulation) and may become available if there is condensation on the piping (as a result of the temperature dropping below dew point).

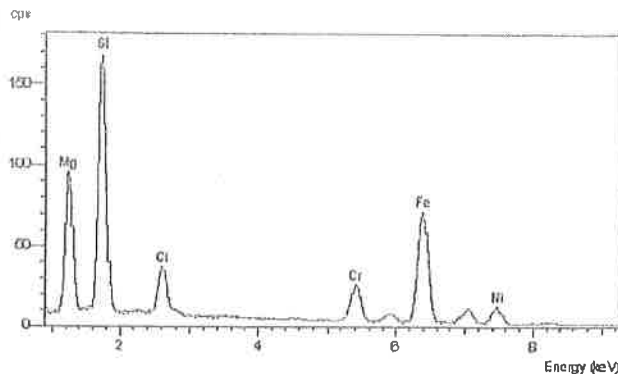
The external surface of a crack was also analysed to measure the concentration of chemical species and possible contaminants. EDX of the external surface of the crack shows the presence of chlorine (chlorides), silicon (silicates) and magnesium (magnesium compounds) (Figure 5). There was however, no evidence of

Figure 5. EDX of external surface of pipe and crack.

boron in any of the EDXs, which would be indicative of through-wall defects where process fluid was leaking out. The presence of the high concentrations of chlorides and absence of any other contaminants that can initiate and propagate SCC implies that it is chloride contamination that is exclusively responsible for the chemical contamination element of the stress corrosion cracking.
