Memo

To: Bob Halstead
From: Marvin Resnikoff
Date: 7/18/2013
Re: NUREG-2125 Review

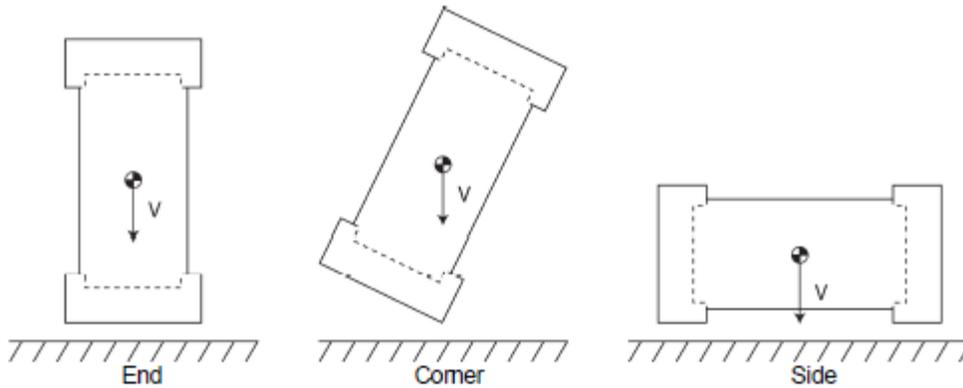
Figure 3-1 Impact orientations analyzed

NUREG-2125 considers the standard impact orientations, shown in Fig. 3.1 below. Each of the orientations takes into account the energy absorption of the impact limiters. For the truck cask, in particular, a detailed analysis in NUREG-2125 for orientations in Fig. 3.1, was not carried out because, according to NUREG/CR-6672, there were no gaps between the lid and the cask body at any impact speed for the orientations in Fig. 3-1. This holds for a steel-DU truck cask, such as the GA-4 cask.

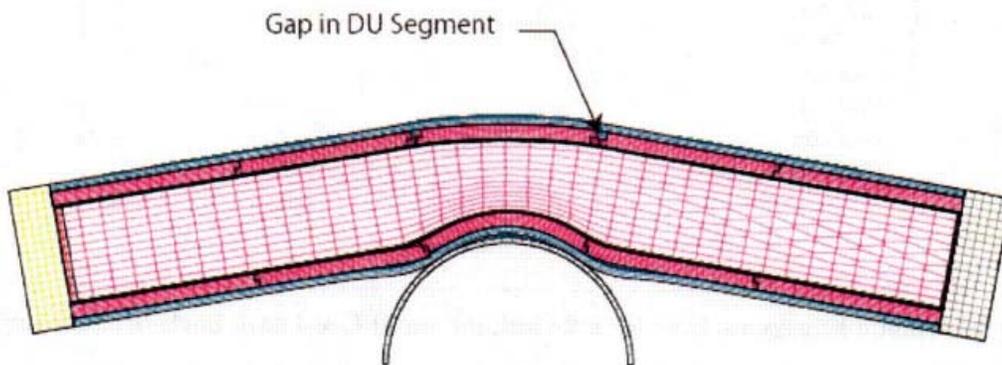
Figure 34. GA-4 cask after 96 kph [60 mph] back-breaker impact.

The back-breaker scenario was considered in the Package Performance Study¹ (PPT) (see Fig. 34 below). The NRC claimed “the level of strain was not high enough to cause tearing of the containment boundary and there was no permanent deformation in the closure region and no loss of containment.” No “permanent deformation” does not mean “temporary displacement” when bolts stretch. As discussed below regarding the interaction of an engine train sill and cask, the bolts can stretch and the opening of the cask lid can indeed remain open. Other details, such as the internal pressure also need to be considered.

As seen in Fig. 34, the interior of the cask was modeled as a solid composite, rather than as individual fuel assemblies, shown in the cross-section of the GA-4, Fig. 1. In addition, the ends of the cask were not modeled to include impact limiters which add one-ton weights to each end of the cask, similar to a barbell.

Most importantly, the bolts and cask cover were not modeled in detail in the PPT, so it is not possible to state that there was “no loss of containment.” A stretching of the bolts would allow gases and fine particles to be released. Without detailed modeling of the bolt region, it is not possible to state “permanent deformation” could not occur.

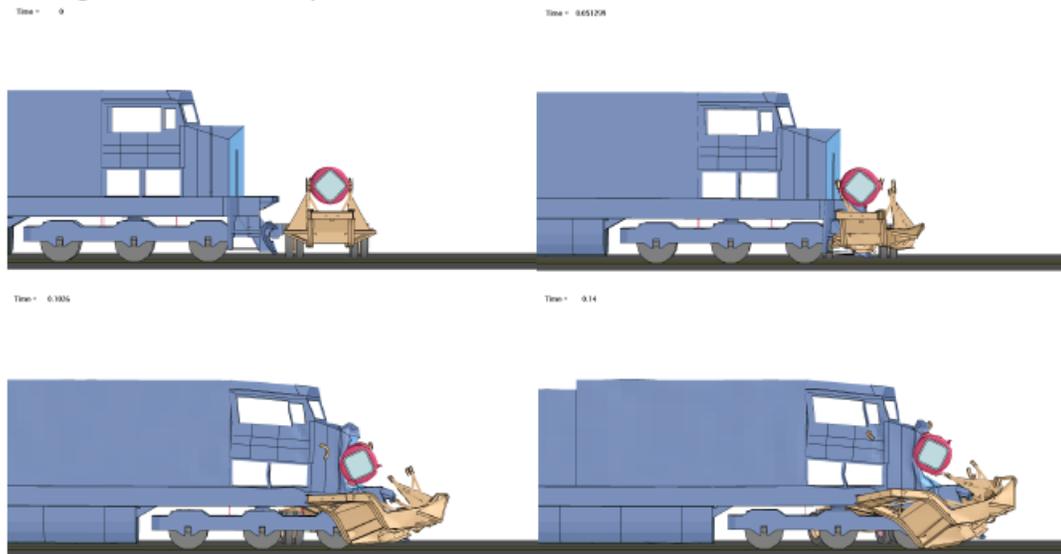
Figure 3-19 Sequential views of a 129 kph (80 mph) impact of a locomotive into a GA-4 truck cask
Figure source: (Ammerman et al., 2005)

NUREG-2125 cites a study by Ammerman⁴, also the author of NUREG-2125, to show that no radioactive material would be released in an impact of the GA-4 cask with a train sill. The Ammerman study investigated the impact of a locomotive into the side of the GA-4 truck cask, shown in the graphic below.

As seen, with the assumed height of the cask on the truck bed, the cask rolls into the sheet metal of the engine and is not directly impacted by the solid engine undercarriage or sill plate. The Sandia crash films show a similar scenario. But, other scenarios are possible. If the track bed at the railroad crossing were raised (hump crossing), and the truck straddled the track bed, as shown in Fig. 2 below, the solid part of the engine (sill plate) could strike the cask directly. This more serious impact was considered by Ammerman. At 70 mph, the cask bolts would stretch 0.059", above yield, and a gap of 0.043" would remain. The cask would experience forces of 140g. Some radioactive material would be released from the cask, but Ammerman could not quantify the amount because individual fuel assemblies and internal pressure in the cask and fuel assemblies were not modeled; the entire contents of the cask were one homogeneous block. Sanders *et al*⁵ claim that the forces would need to exceed 200 g for the fuel assembly cladding to fail, but the analysis assumed the cask would remain rigid, which is not so for the back-breaker case.

Further, in the Ammerman model, the one-ton impact limiters were not included; inclusion of one-ton impact limiters would have increased the bending of the cask when struck by the locomotive.

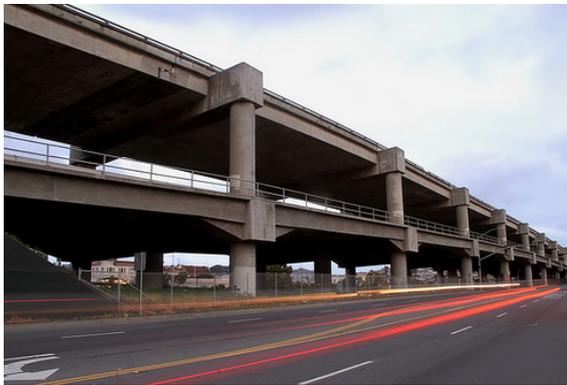
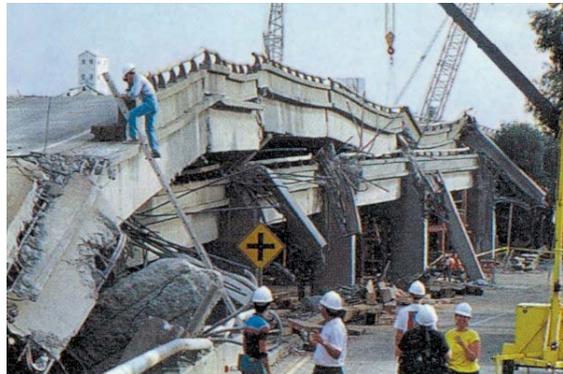
Fig. 3. Cypress Street Viaduct Before and After Collapse

The Cypress Street Viaduct was a 1.6 mile long, raised two-tier, multi-lane (four lanes per deck) freeway constructed of reinforced concrete that was originally part of I-880 in Oakland, California. It officially opened to traffic on June 11, 1957 and was in use until the 1989 Loma Prieta earthquake, when much of the upper tier collapsed onto the lower tier due to poorly designed bridge columns. Fig. 3 below shows the before and after of the Loma Prieta earthquake.
