Critique: EPRI Flaw Growth and Flaw Tolerance Assessment for Dry Cask Storage Canisters

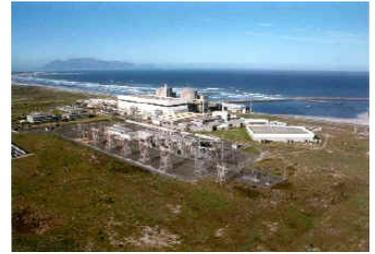
The Koeberg plant is in a similar to environment to West Coast plants (frequent on-shore winds, crashing surf and fog) – known conditions for higher chloride-induced stress corrosion cracking risk. **These conditions were excluded from EPRI’s assumptions and calculations.**

For example, the EPRI report excluded the Koeberg, South Africa refueling water storage tank (RWST) that failed in 17 years with a crack over .60" (15.5 mm) deep, (greater than the thickness of most U.S. thin canisters), yet they call their work "conservative". And EPRI did not mention that crack growth rate would be faster in higher temperature spent fuel canisters. By using the words "in general" and leaving out examples that do not fit their conclusions, they create a misleading view of the facts.
